MEASUREMENT OF FLYING QUALITIES OF A DEHAVILLAND

MOSQUITO F-8 AIRPLANE (AAF NO. 43-334960)

I - LATERAL AND DIRECTIONAL STABILITY

AND CONTROL CHARACTERISTICS

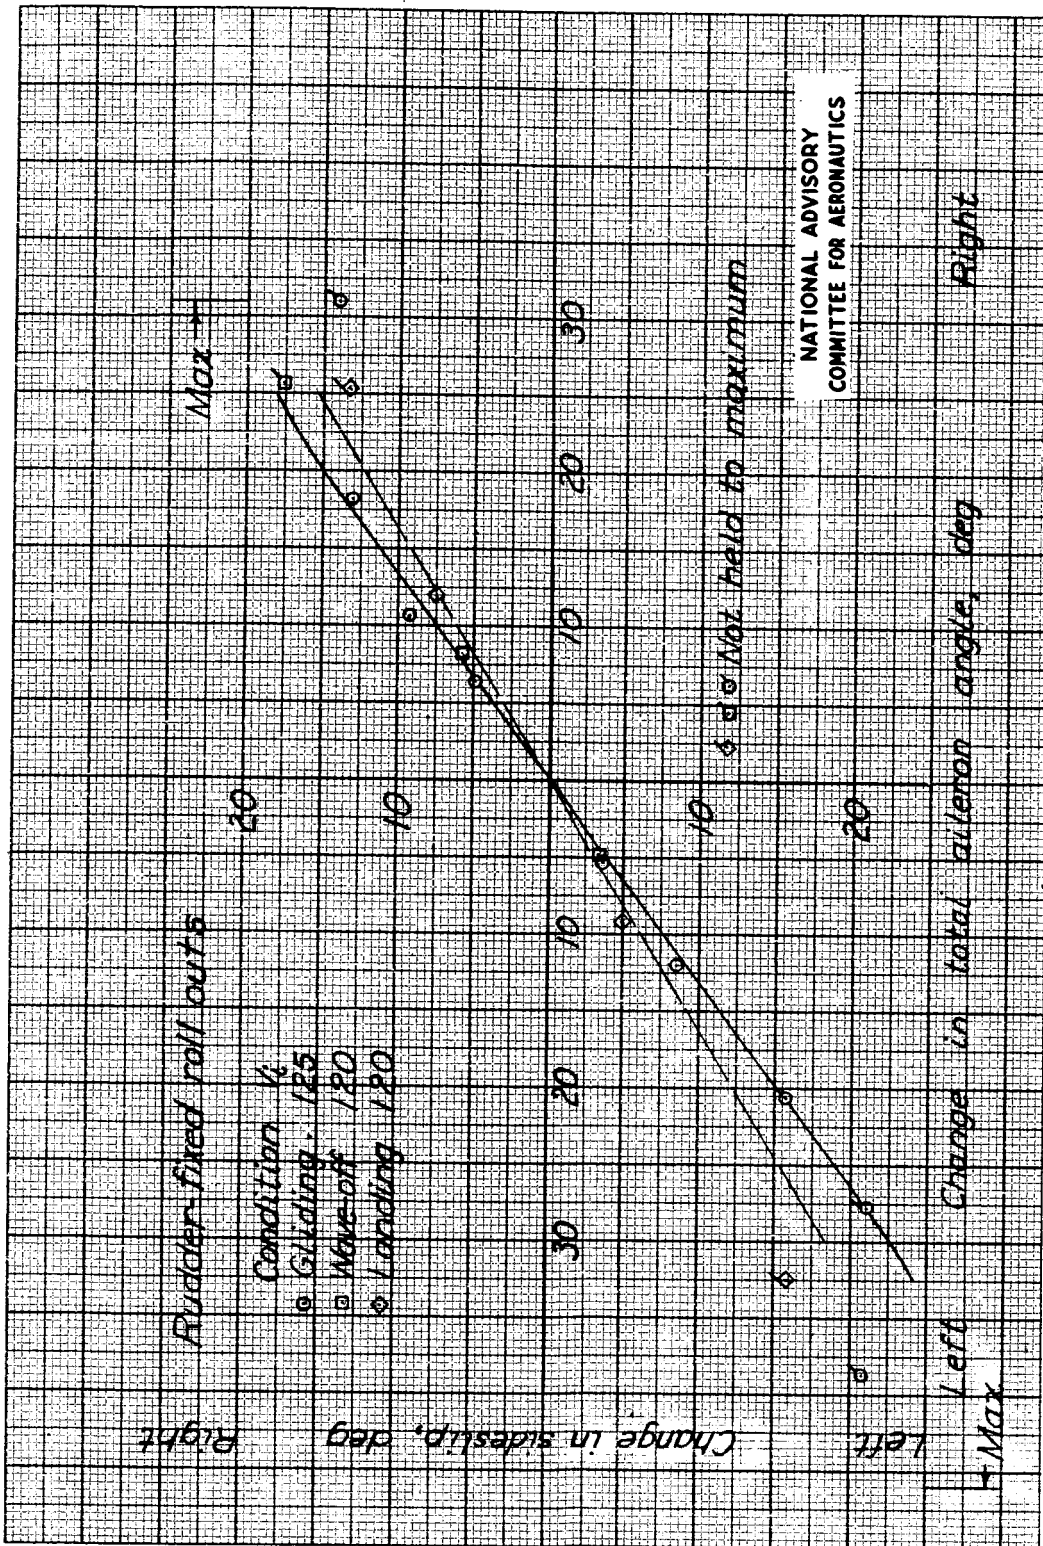
Figure 11. - Variation of maximum change in sideslip angle with change in total aileron angle for several flight conditions, DeHavilland Mosquito F-8 airplane.

coordinated rudder are given in figure 10. The variation of maximum angle of sideslip with total aileron deflection in rudder-fixed roll-outs at low speeds is presented for several conditions in figure 11. The directional stability as indicated by the data of figure 11 was about equal in the gliding and wave-off conditions and slightly greater in the landing condition. The maximum angle of sideslip due to aileron deflection reached in the gliding condition was over  $20^\circ$  and therefore the requirements of reference 1 were not met. It was not always possible for the pilot to continue the maneuver until a maximum angle of sideslip was reached because of the pitching moment due to yawing. In figure 10(c) two rudder-fixed roll-outs are presented for the wave-off condition at 115 miles per hour during which the airplane pitched down abruptly as indicated by the pitching velocity and normal acceleration and in the right roll caused both engines to cut out. This figure also shows aileron shaking which was often noticed when the ailerons were fully deflected.

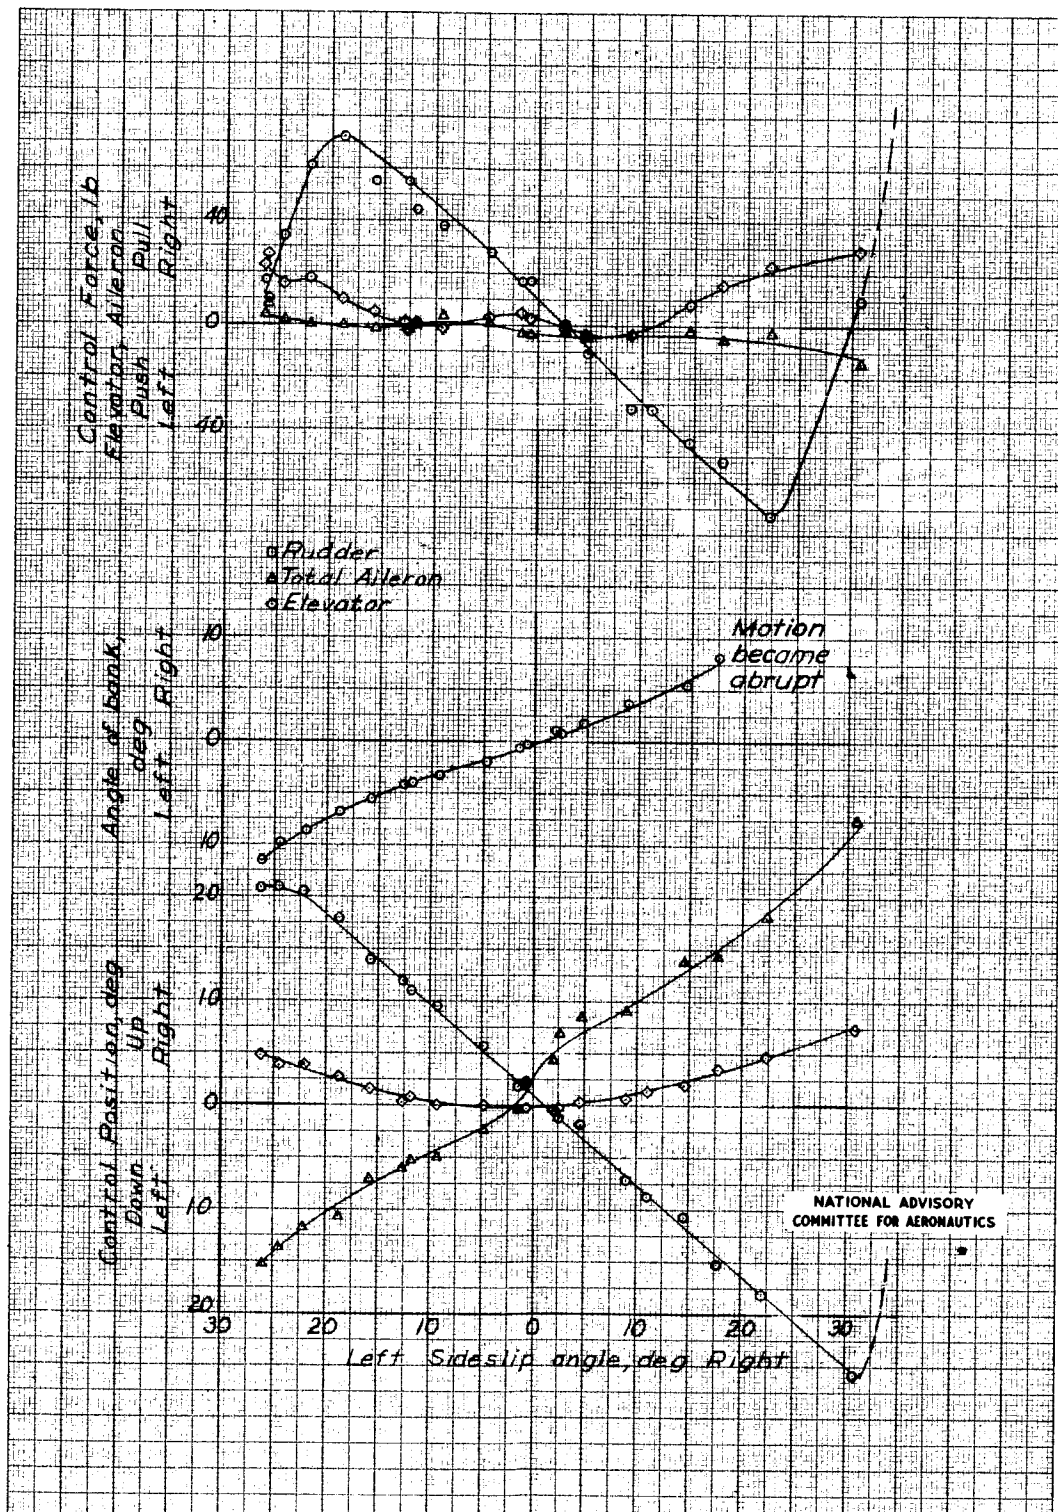
Figure 12. - Sideslip characteristics from continuous records in the clean condition at 115 miles per hour with power for level flight (2650 rpm,  $-\frac{3}{4}$  pounds boost) shutters open, DeHavilland Mosquito F-3 airplane.

The stick-fixed dihedral effect as shown by the variation of aileron angle with sideslip angle in figures 12 to 16 was positive in all conditions and met the requirements of reference 1. In the gliding condition the effective dihedral was  $4.0^\circ$  compared with  $1.4^\circ$  geometric dihedral at the top surface of the wing. The stick-free dihedral effect as shown by the variation of the aileron force with sideslip angle was marginal to slightly negative in all conditions; the stick forces were very light and hardly out of the range of the friction force in the aileron system which was approximately  $\pm 4$  pounds.

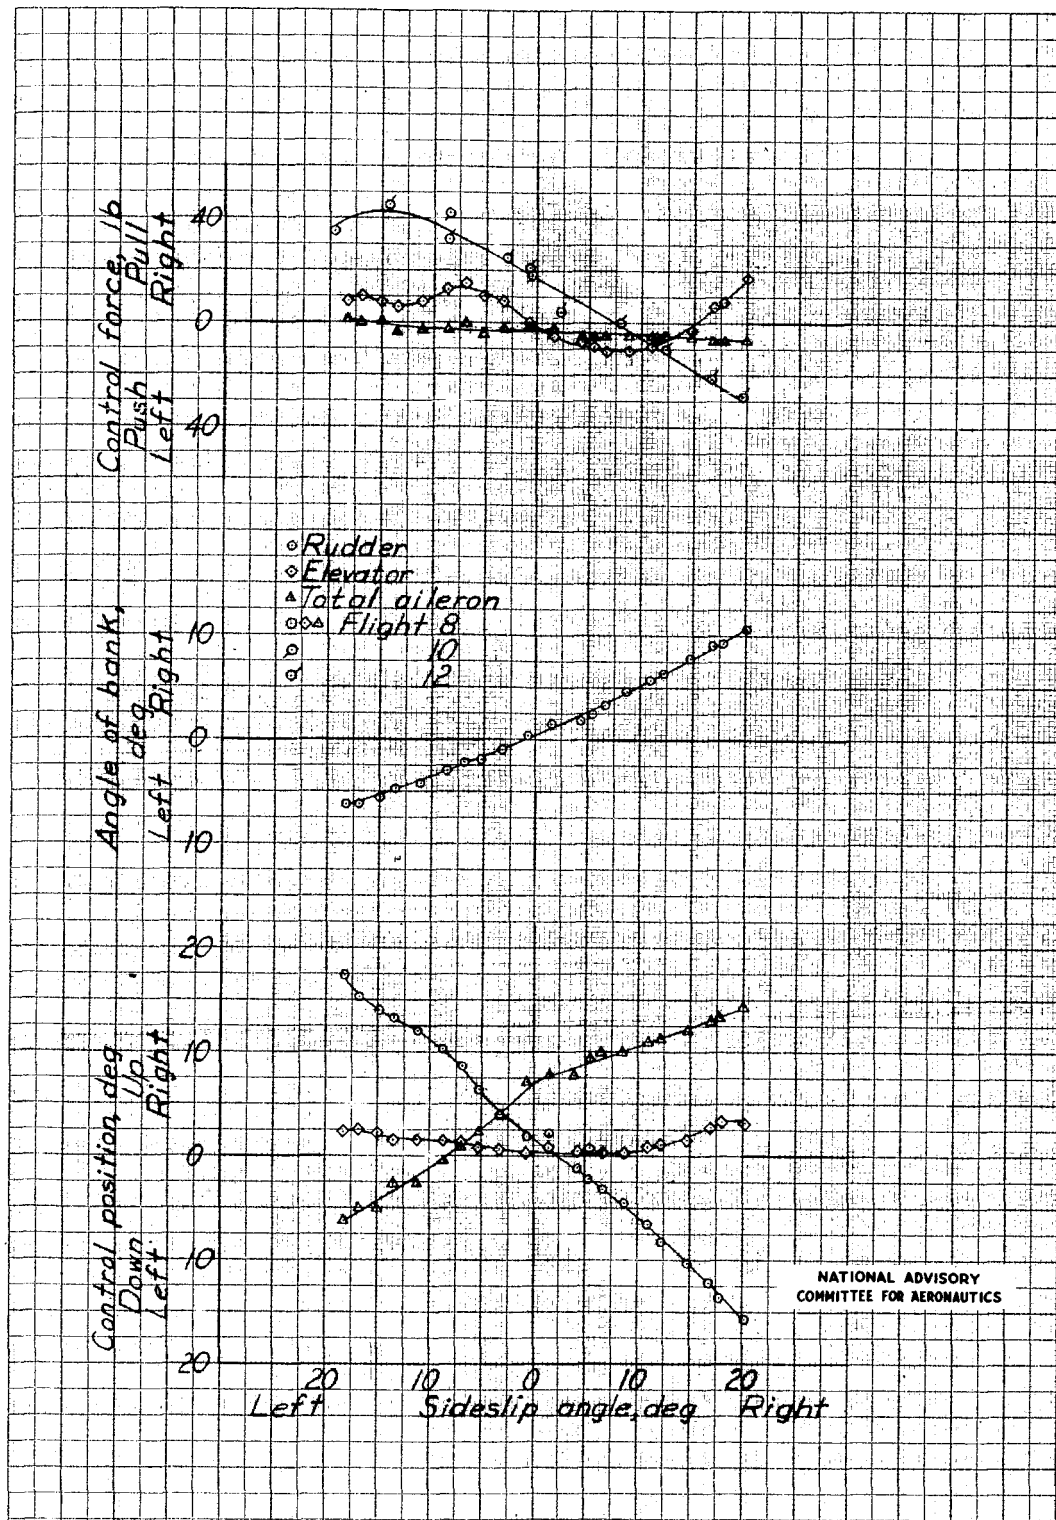
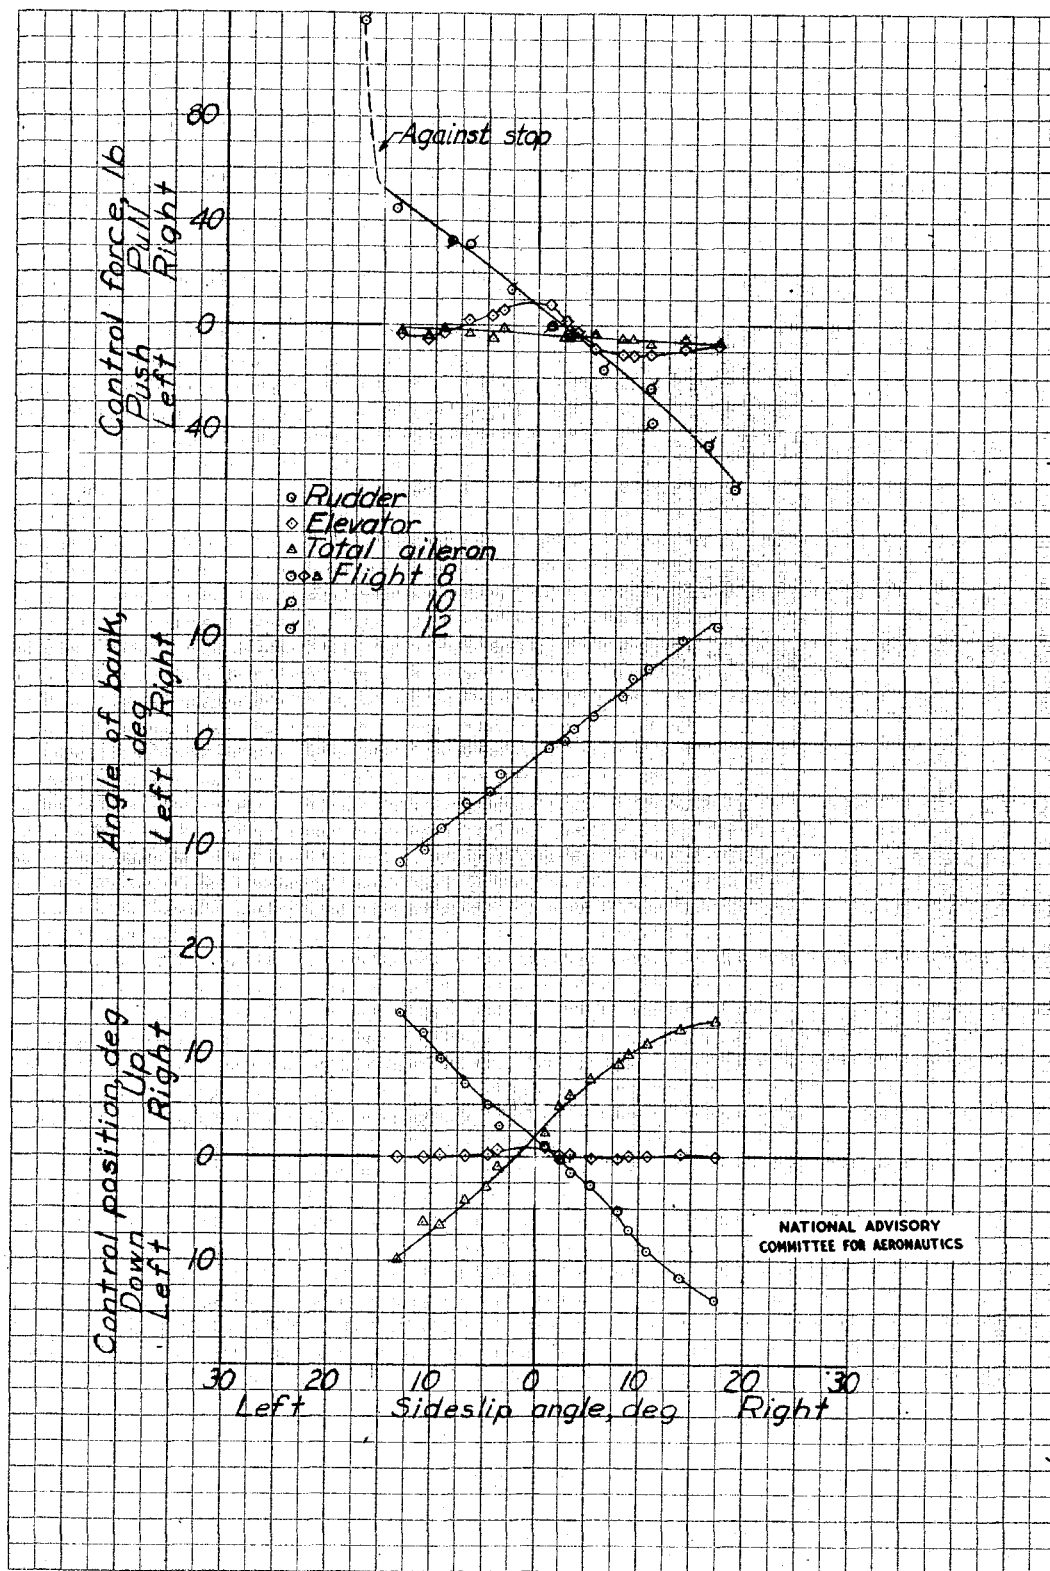
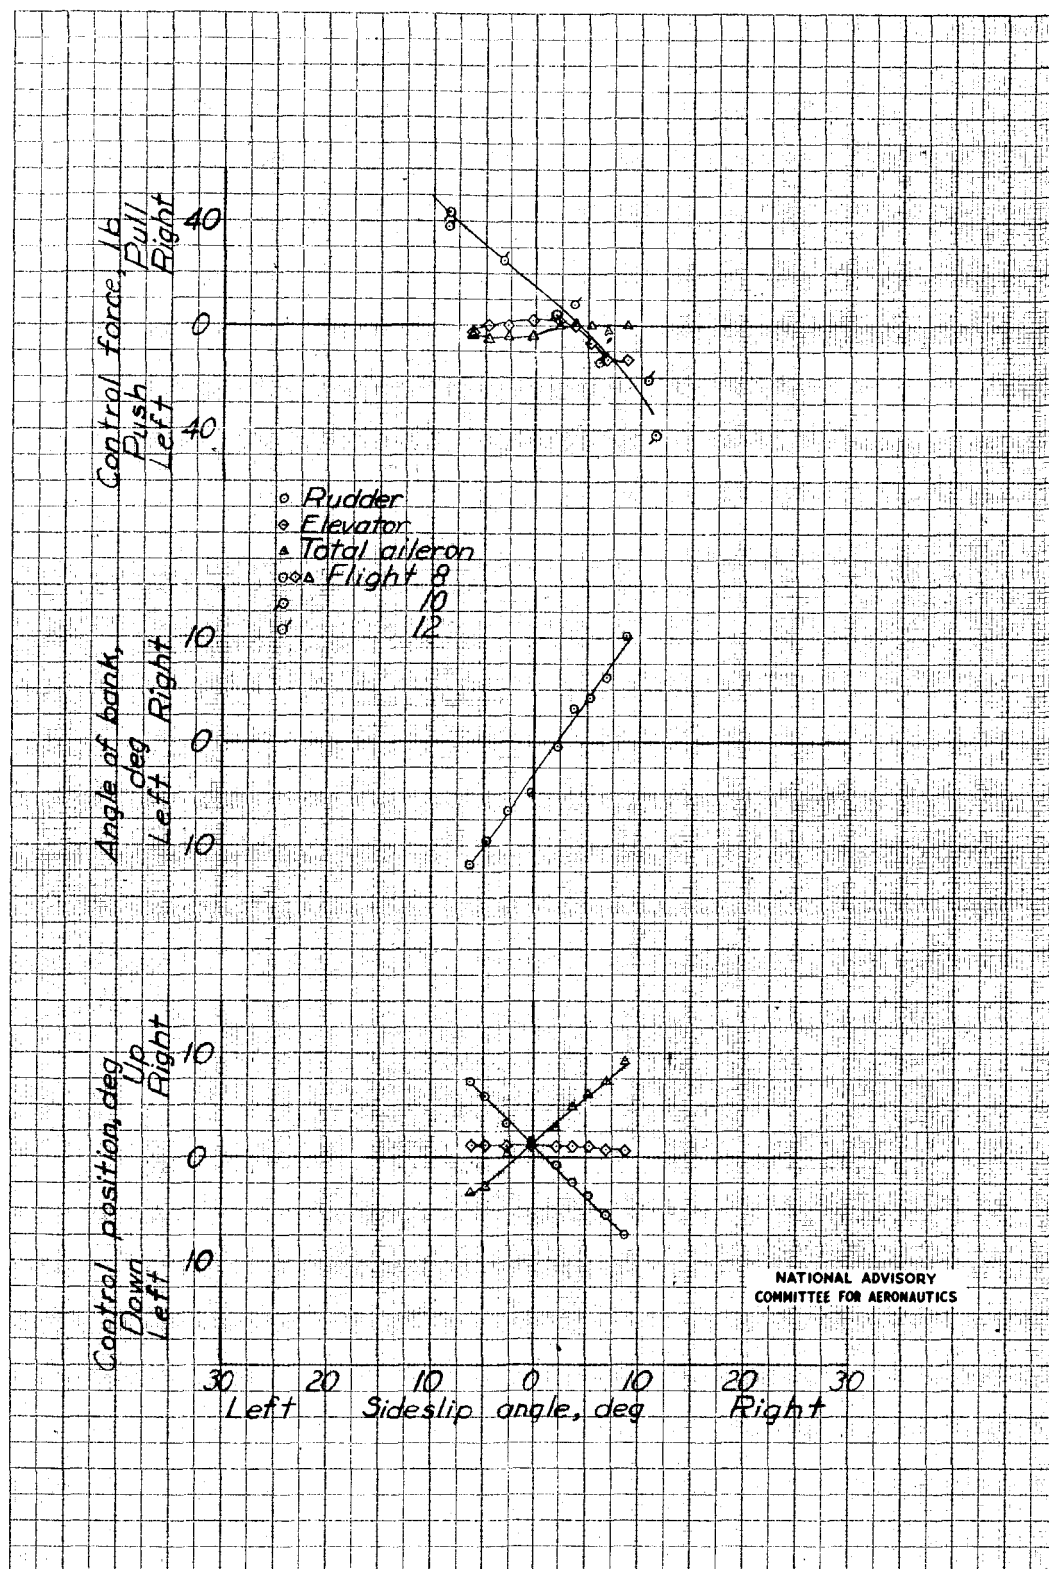
a. 120 miles per hour, shutters open.  
 Figure 13. - Sideslip characteristics in the clean condition  
 with rated power, DeHavilland Mosquito F-8  
 airplane.

b. 180 miles per hour shutters closed.  
 Figure 13. - Continued.

c. 240 miles per hour, shutters closed.  
Figure 13. - Concluded.

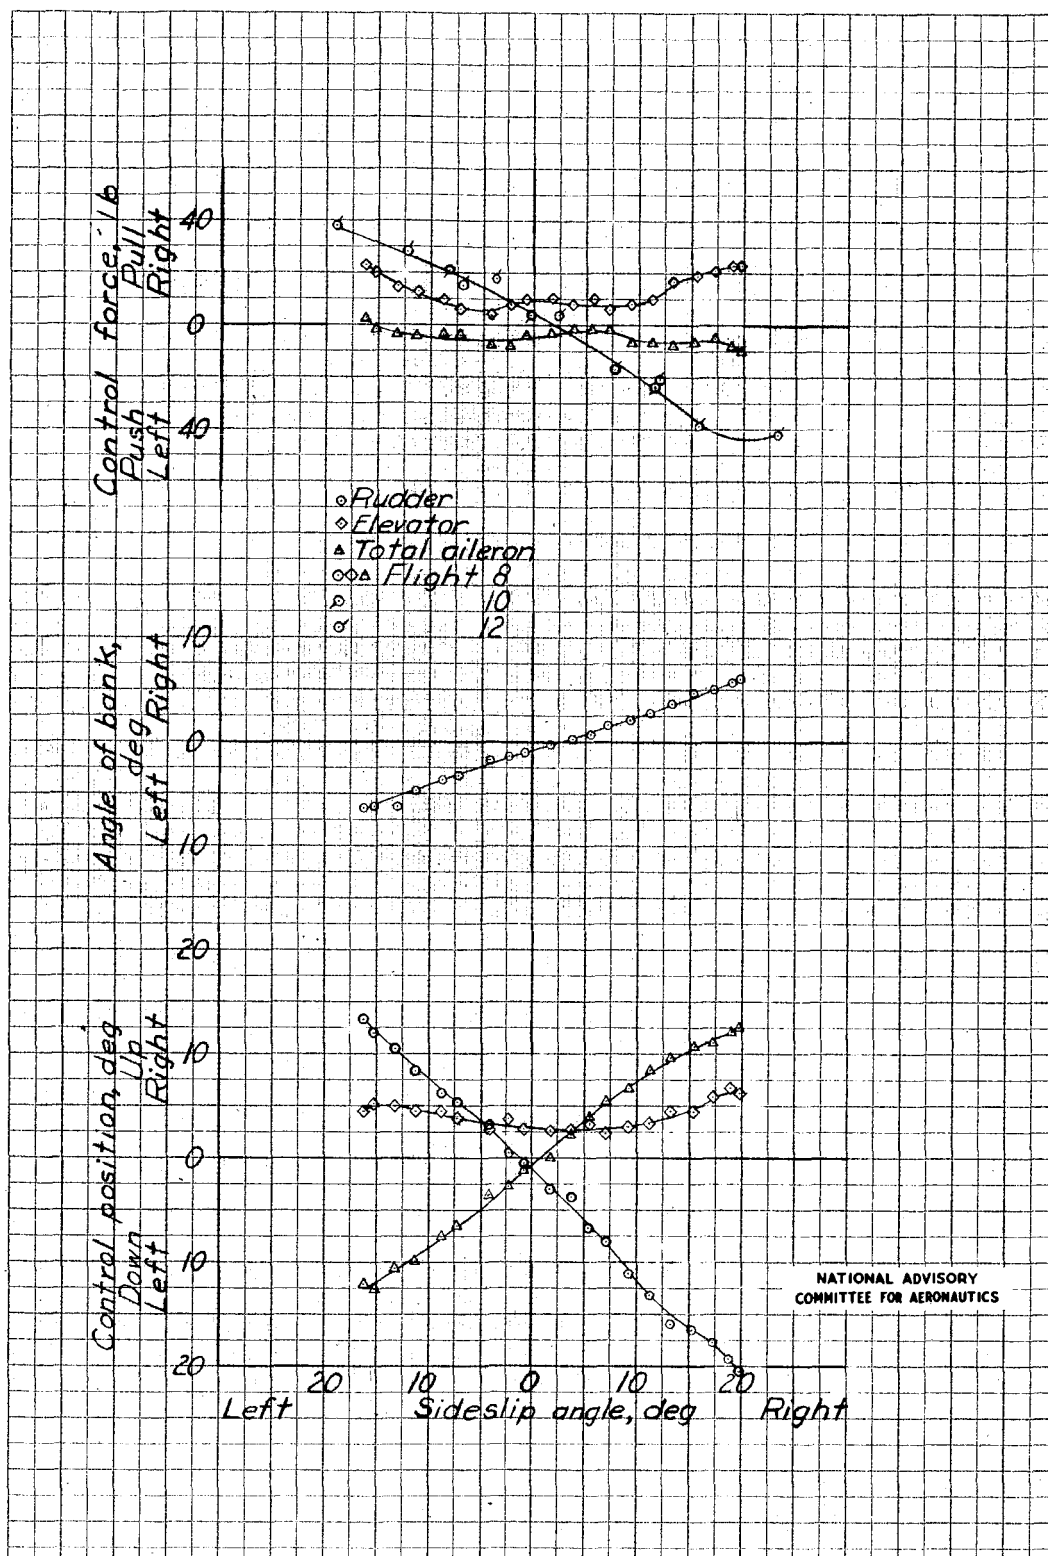
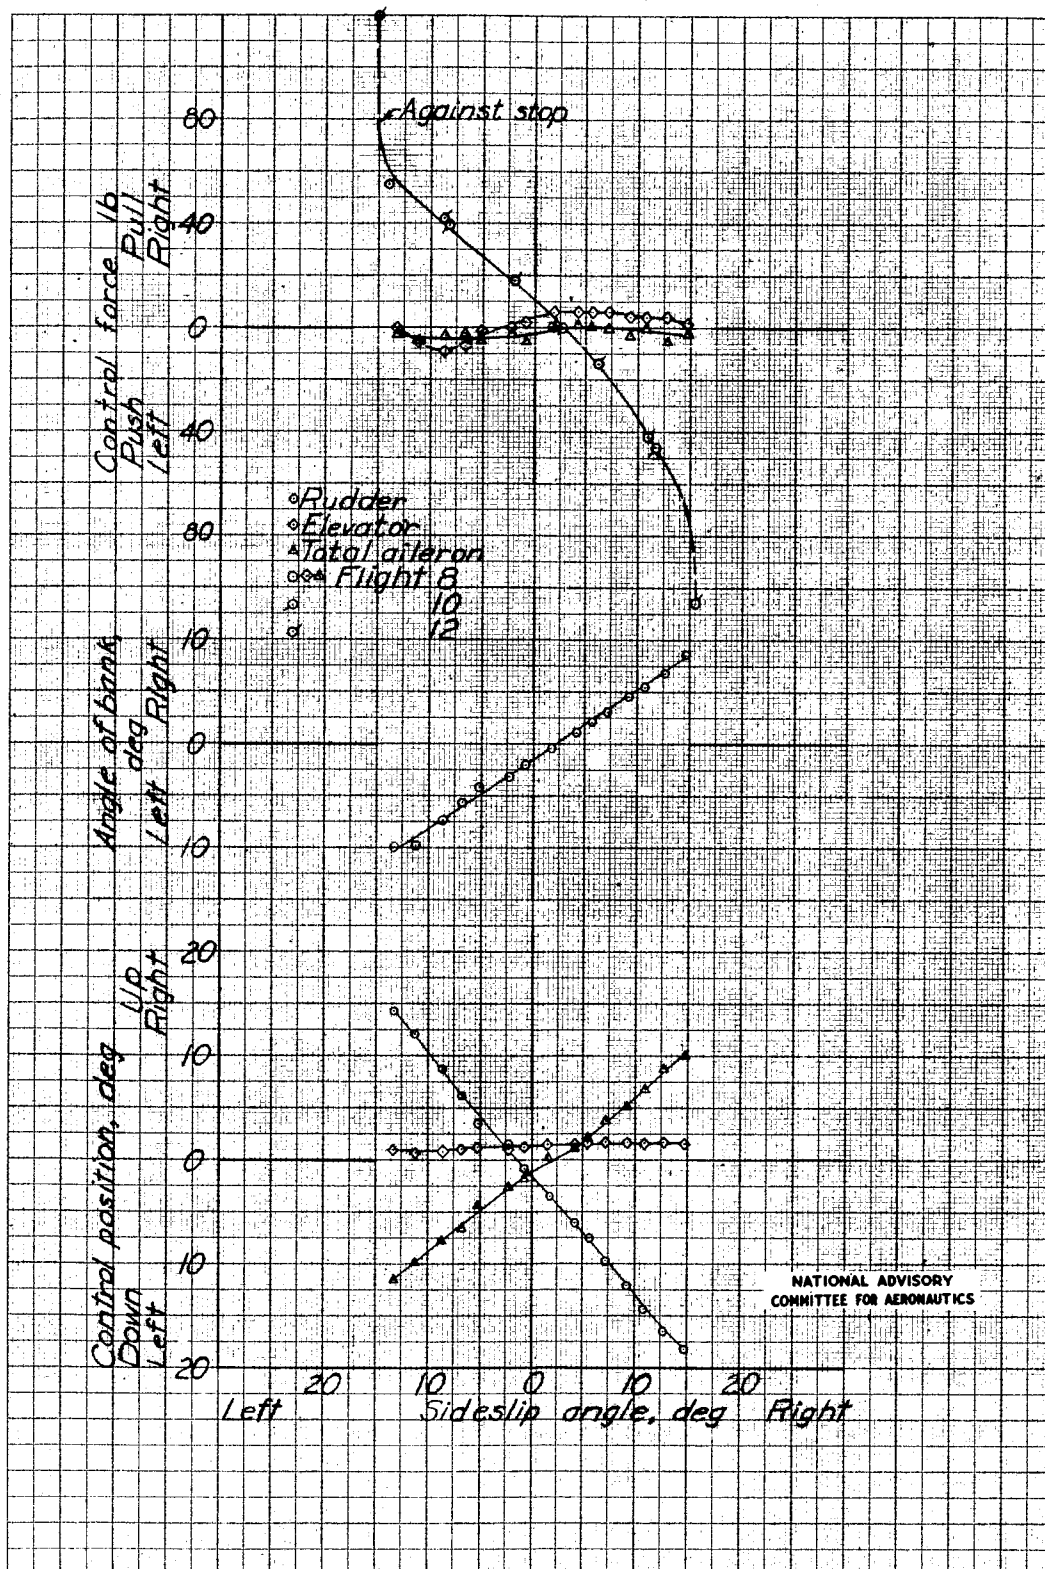
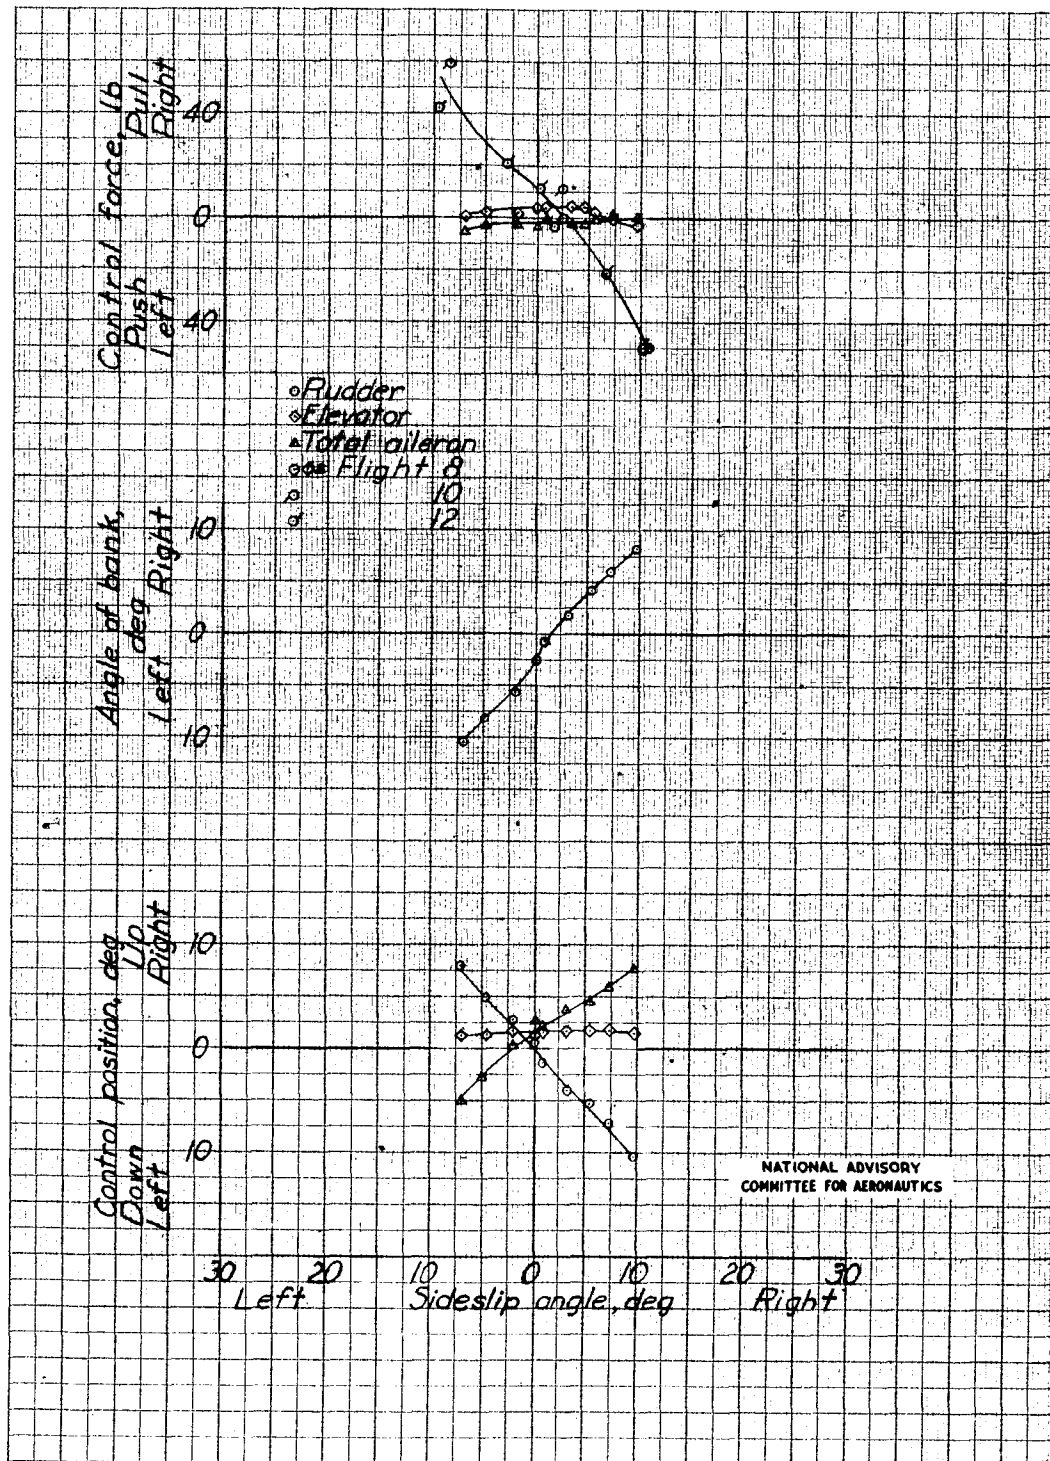
a. 120 miles per hour  
 Figure 14. - Sideslip characteristics in the clean condition  
 with engines idling, shutters closed, DeHavilland  
 Mosquito F-8 airplane.

b. 180 miles per hour  
Figure 14. - Continued.

c. 240 miles per hour  
Figure 14. - Concluded.

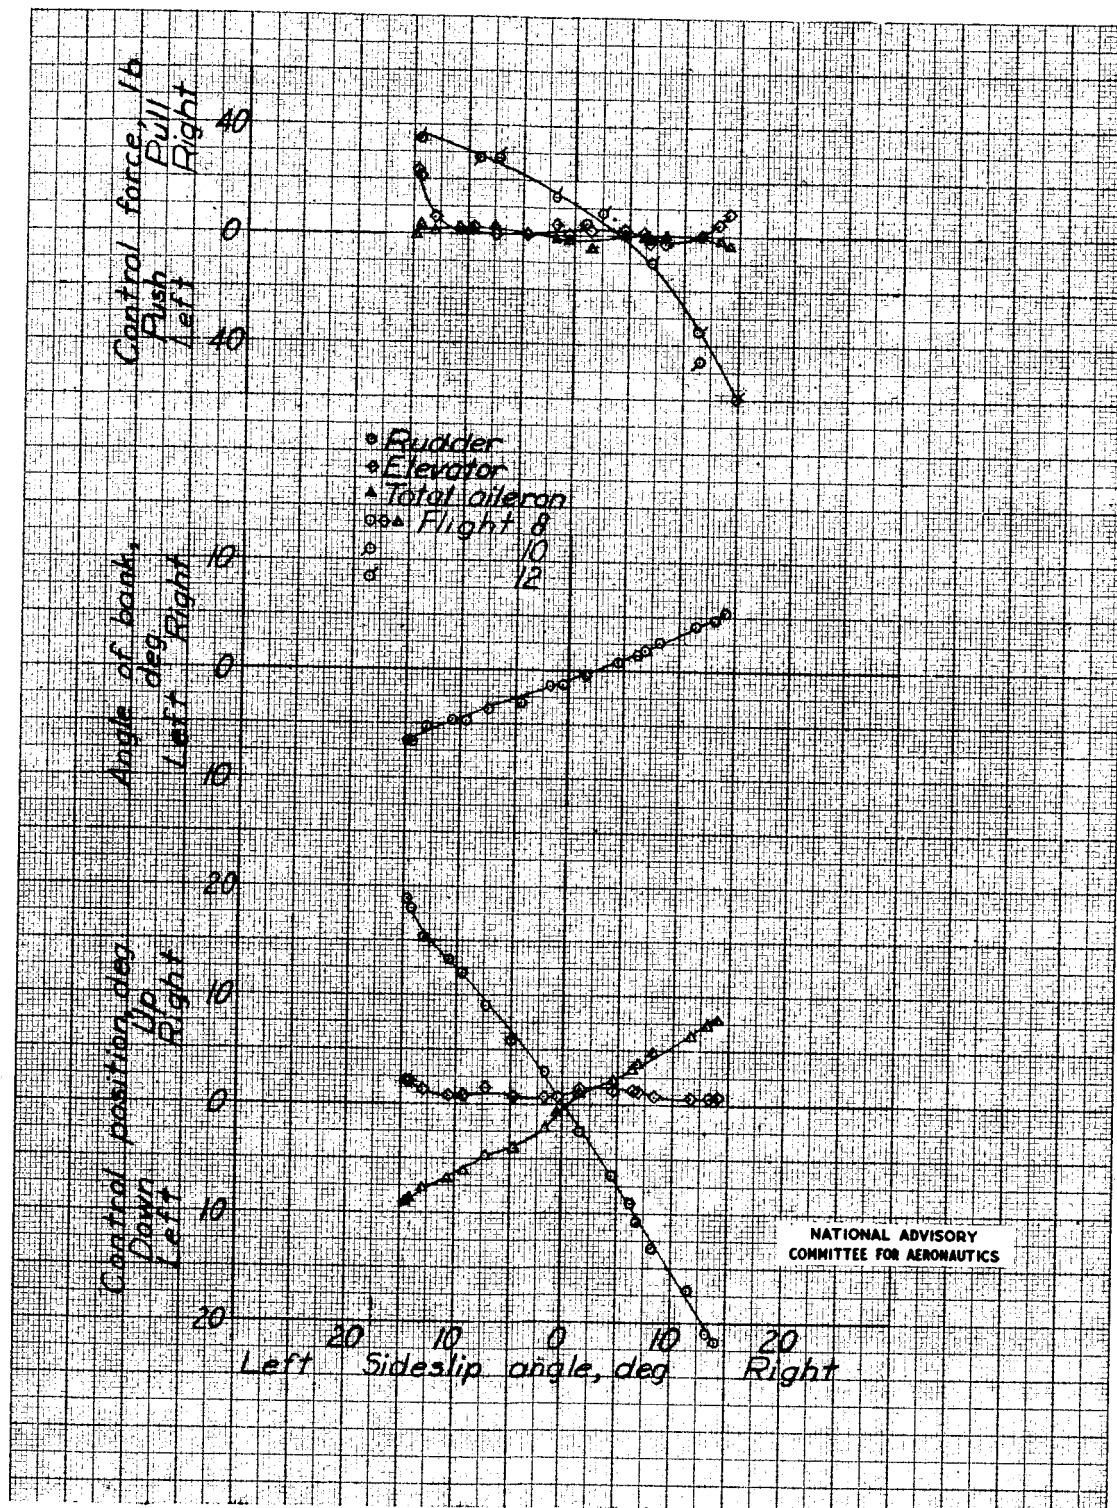
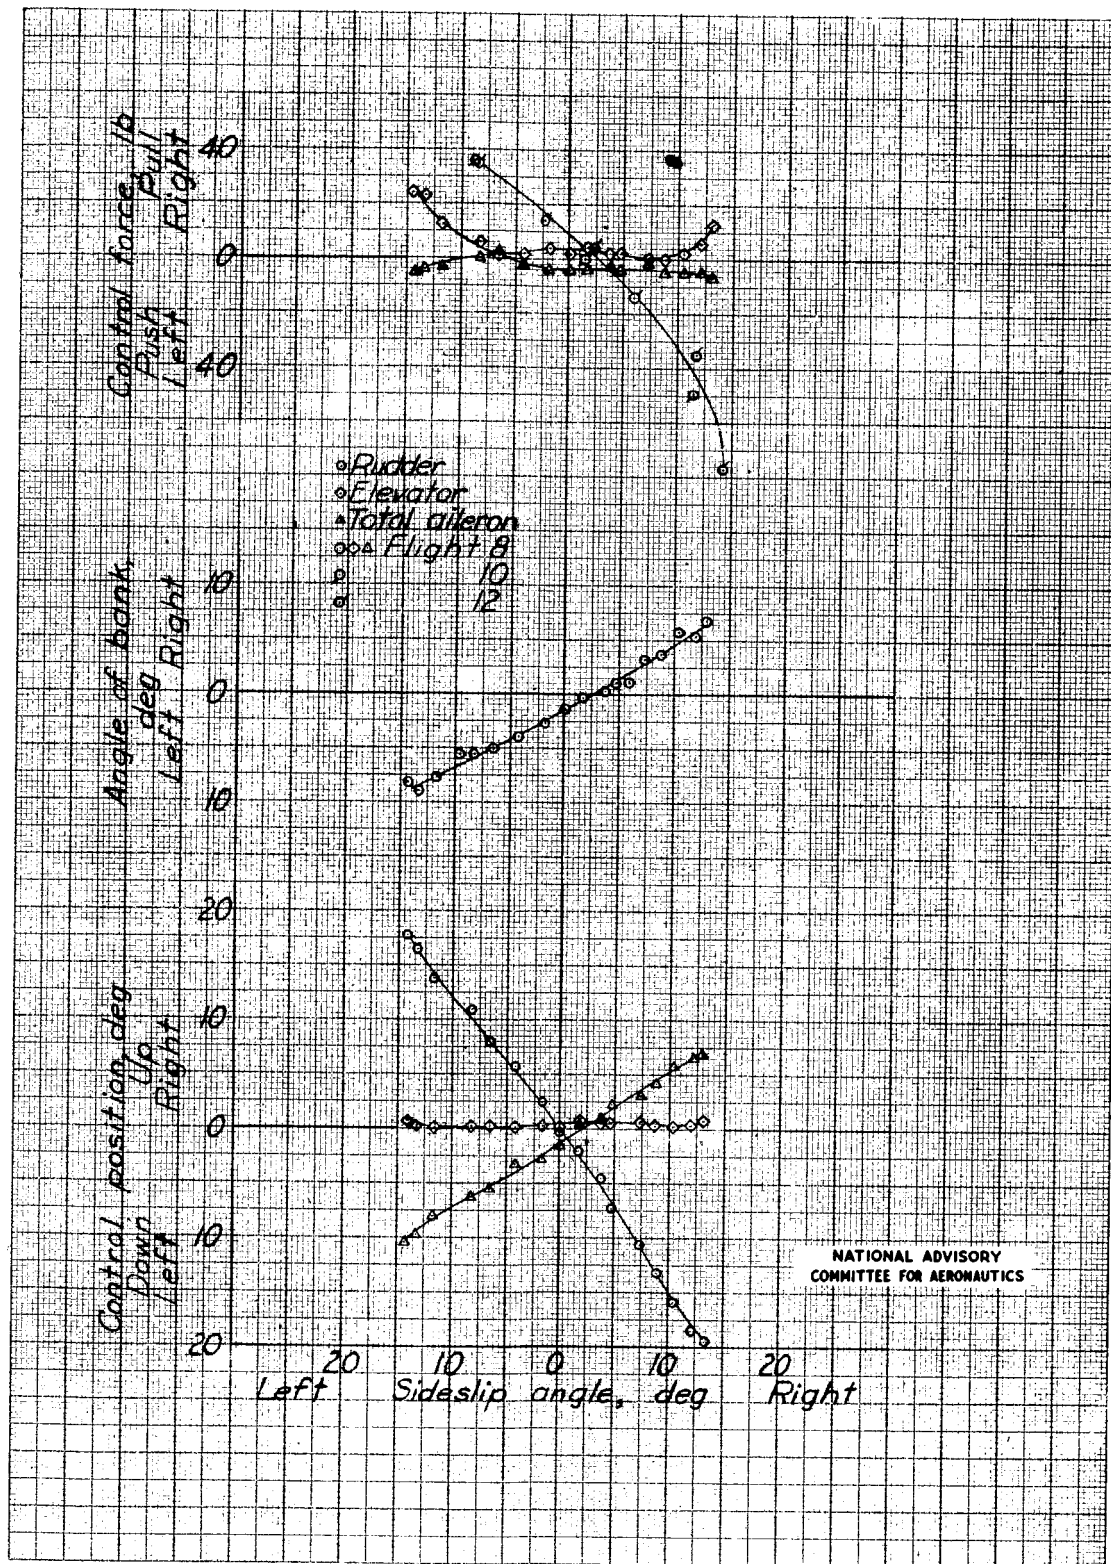
a. 115 miles per hour  
 Figure 15. - Sideslip characteristics with flaps and landing gear down, engines idling, shutters open, DeHavilland Mosquito F-8 airplane.

b. 140 miles per hour  
Figure 15. - Concluded.

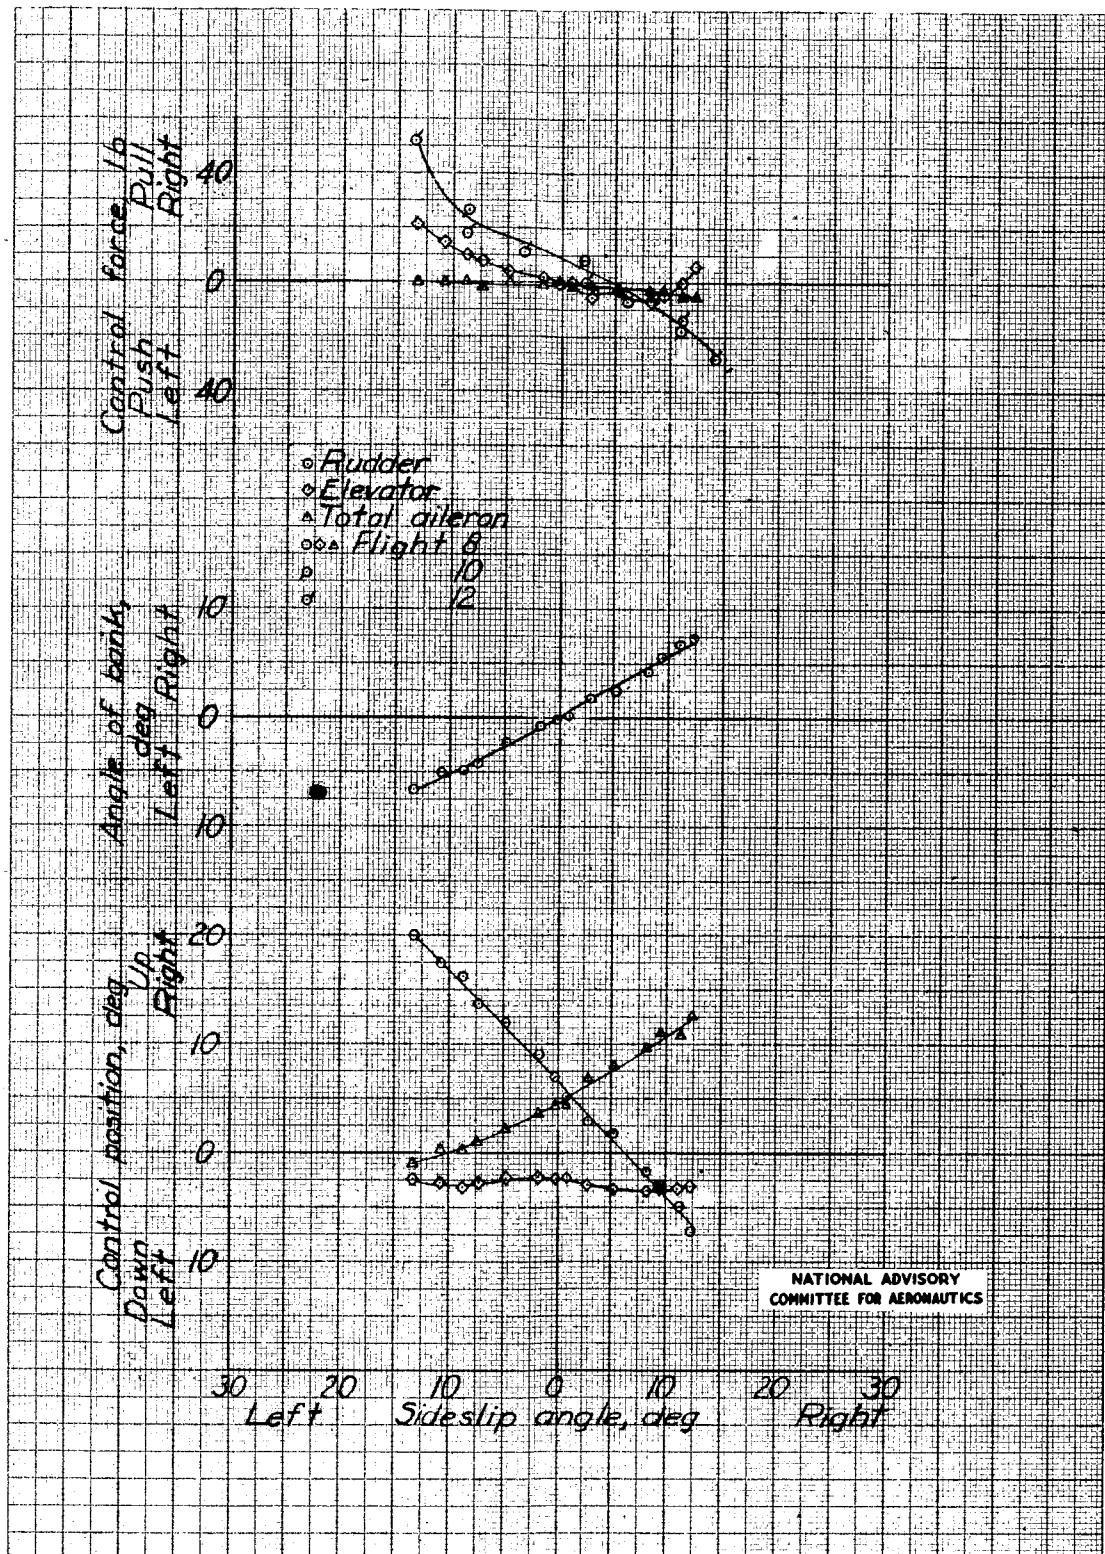
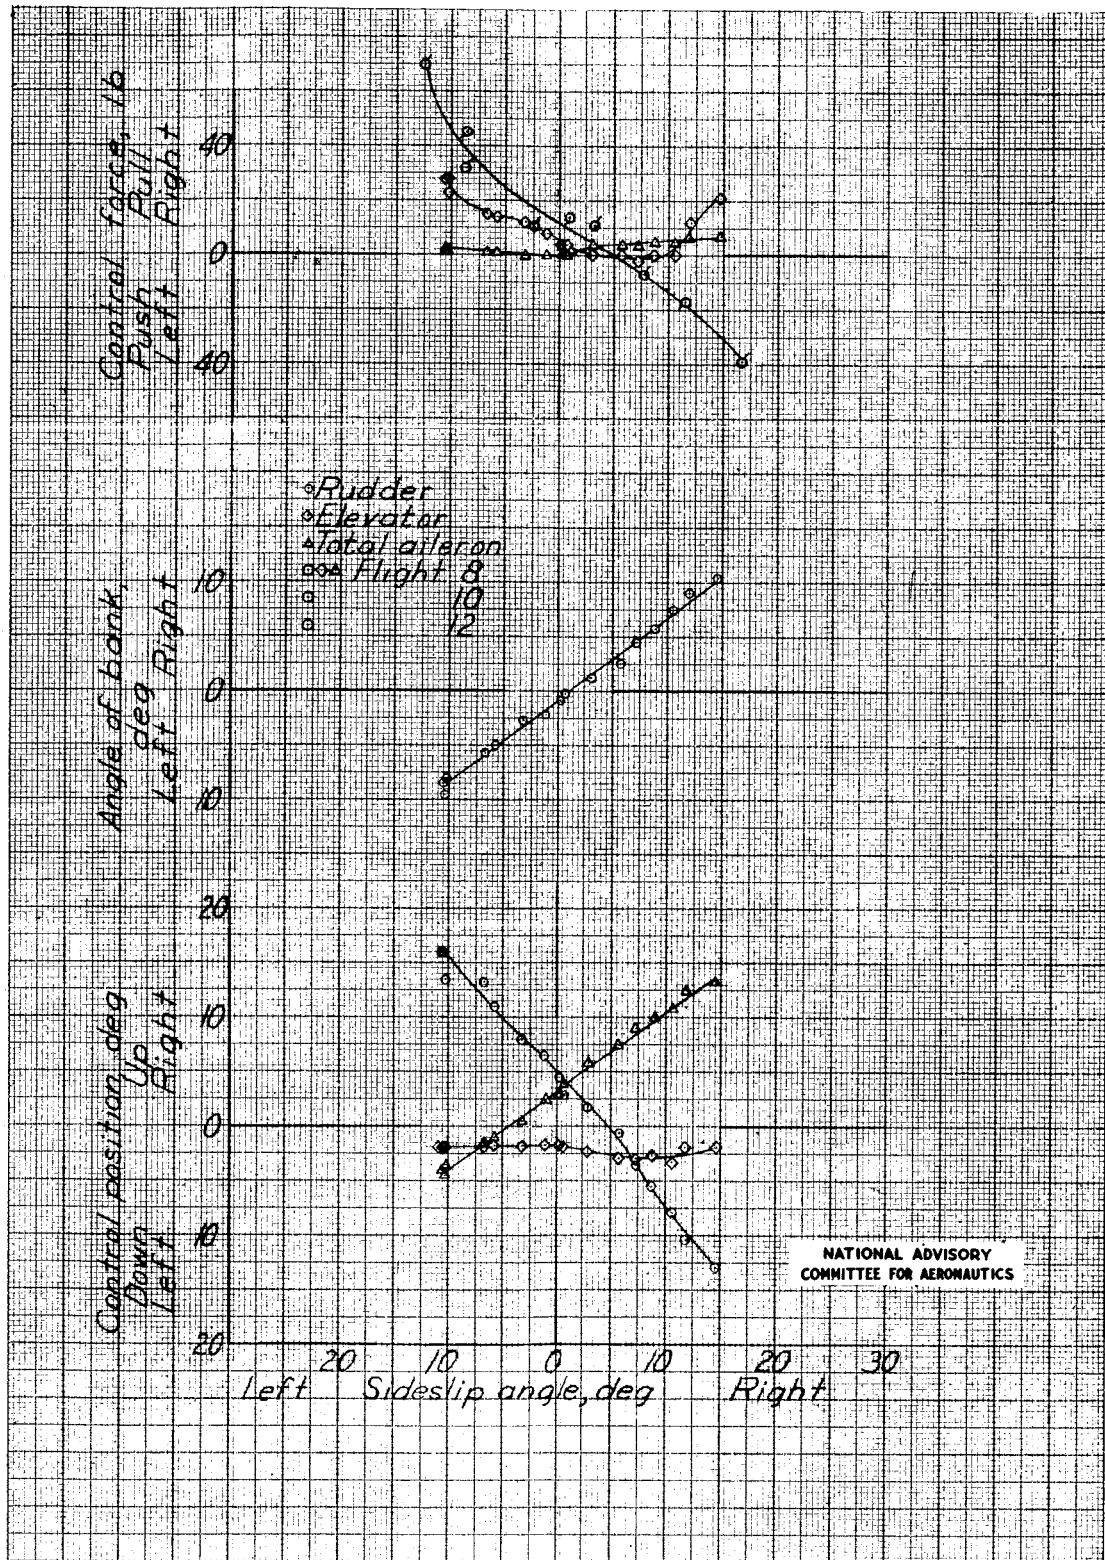
a. 110 miles per hour  
 Figure 16. - Sideslip characteristics with the flaps and landing gear down, rated power, shutters open, DeHavilland Mosquito F-8 airplane.

b. 140 miles per hour  
 Figure 16. - Concluded.

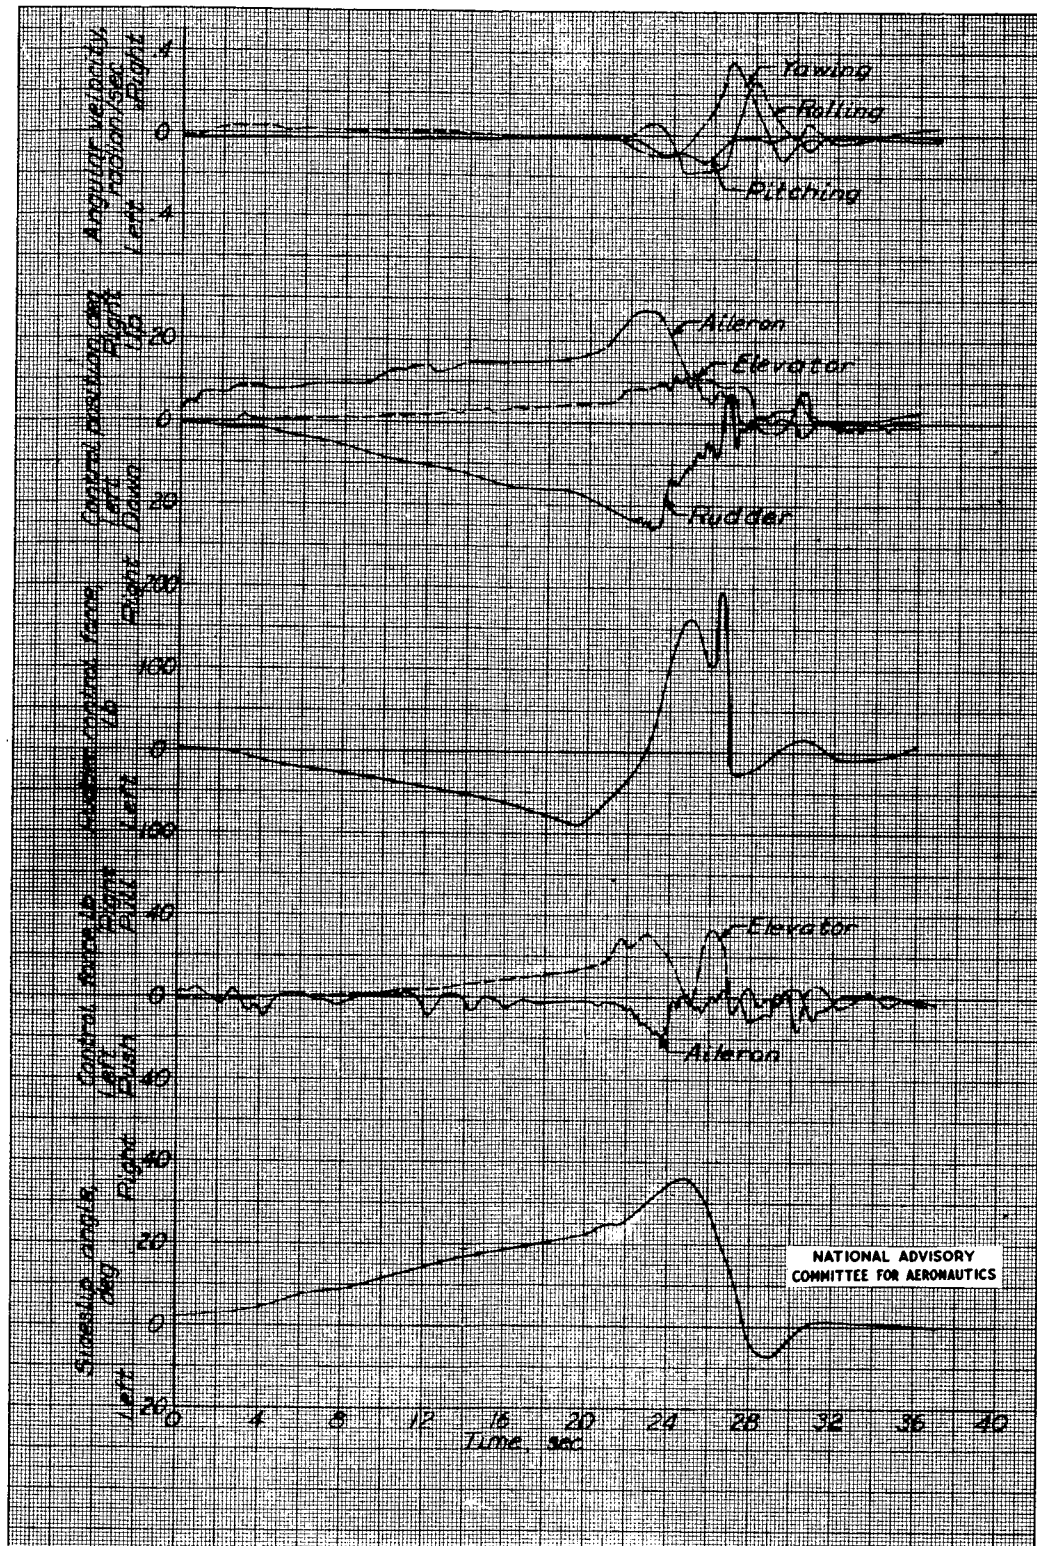
Figure 17. - Time history of right sideslip in the clean condition with power for level flight at 115 miles per hour, shutters open, in which rudder lock occurred, DeHavilland Mosquito F-6 airplane. Engines were cut to regain control.
